HYDRAULIC SYSTEM SEAL DEVELOPMENT

Keith E. Whitfill
VOUGHT CORPORATION
P. O. Box 225907
Dallas, Tex. 75265

June 1981

Final Report for Period September 1978 - October 1980

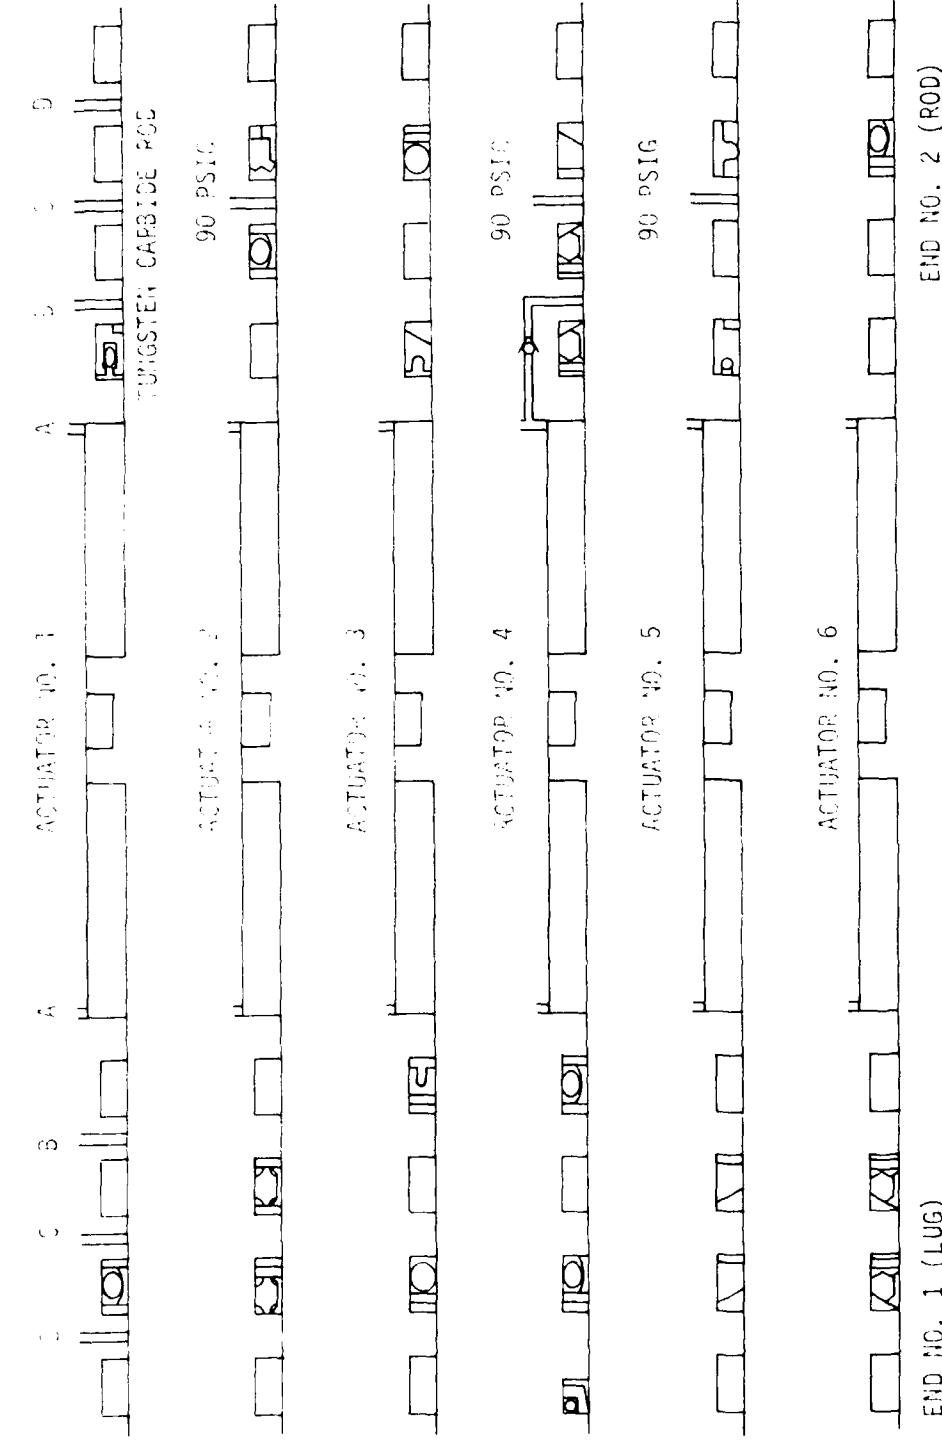
FIGURE 4. SEALS INSTALLED AT START OF TASK II TESTS

During installation of the seals that had been selected for the Task II test it became apparent that some of the seals could not be installed in one-piece glands. Those seals were replaced by alternate seals. The seal configurations that were installed for the Task II test are shown on Figure 4. A seal description for each of the seals is shown in Table B-1 in Appendix B. In this table, the innermost groove is designated as groove A, the next groove is labeled groove B and so on. The Seal Evaluation Test Fixture is shown in Figure B-1 in Appendix B. The Specimen and Load Hydraulic Systems are shown in Figure B-2 in Appendix B.

In Figure 3, as in all successive figures that show the seal installations, the ports into the actuator end caps were identified as A, B, C, and D. The groove adjacent to and outboard from a port had the same letter identification as the port. For example, the innermost groove was adjacent to and outboard from Port A, so that groove was referred to as groove A. Pressure was supplied to ports B, C, and D only if 90 psig was shown at the port. In all other cases the ports were used either to monitor pressure and/or leakage to provide a vent back to the inboard side of the seal groove, or they were not needed and were plugged.

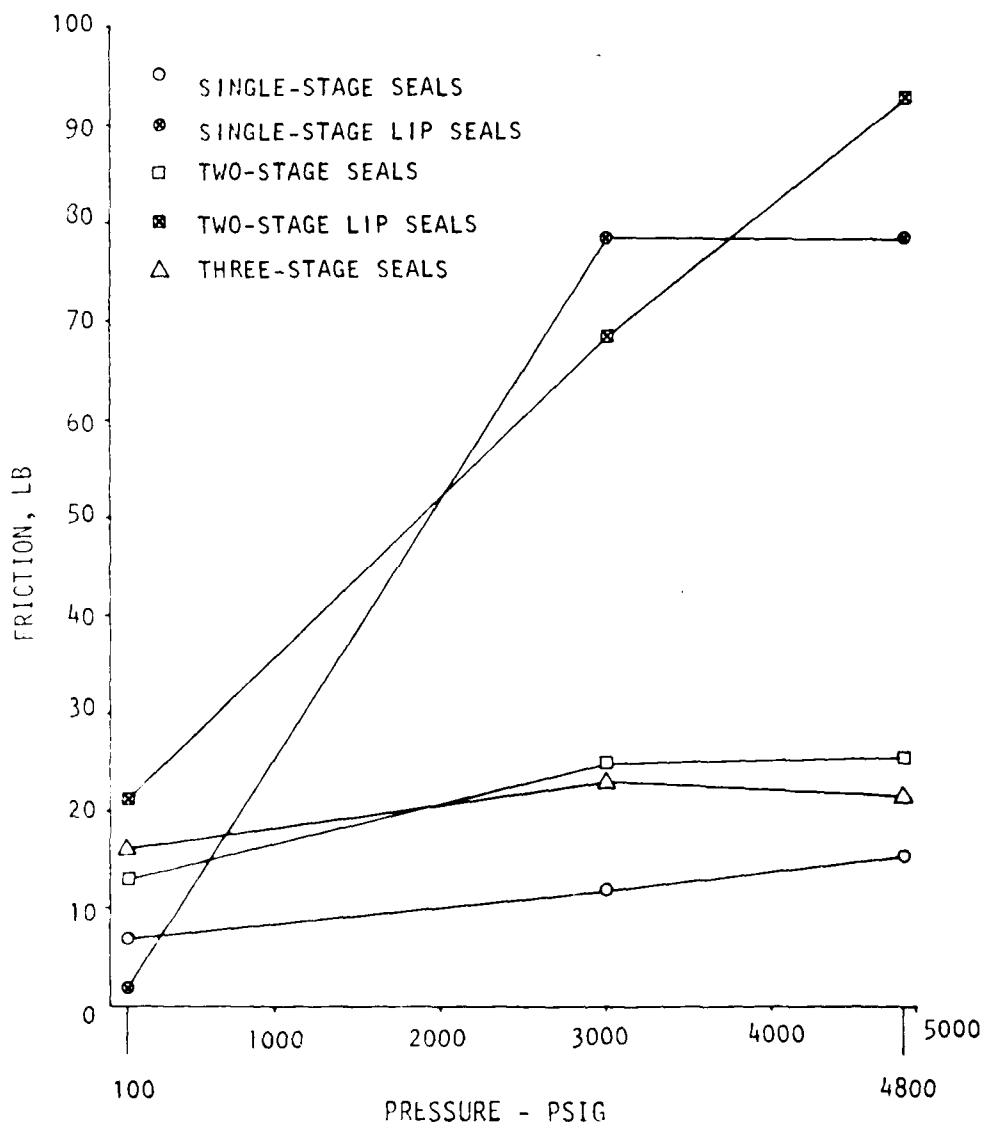
FIGURE 5. PRESSURIZED FRICTION OF TASK II SEALS

The Task II test was performed as shown in Table 5. The long stroke cycles were +/- 1.75 inches with a maximum load of 2318 pounds per actuator. The short stroke cycles were +/- .04 inch with a maximum load of 58 pounds per actuator. The unpressurized friction for the seals is shown in Table 6. The pressurized friction for each seal is shown in Figure 5. The total measured leakage for the seals that survived the test is shown in Figure 6.

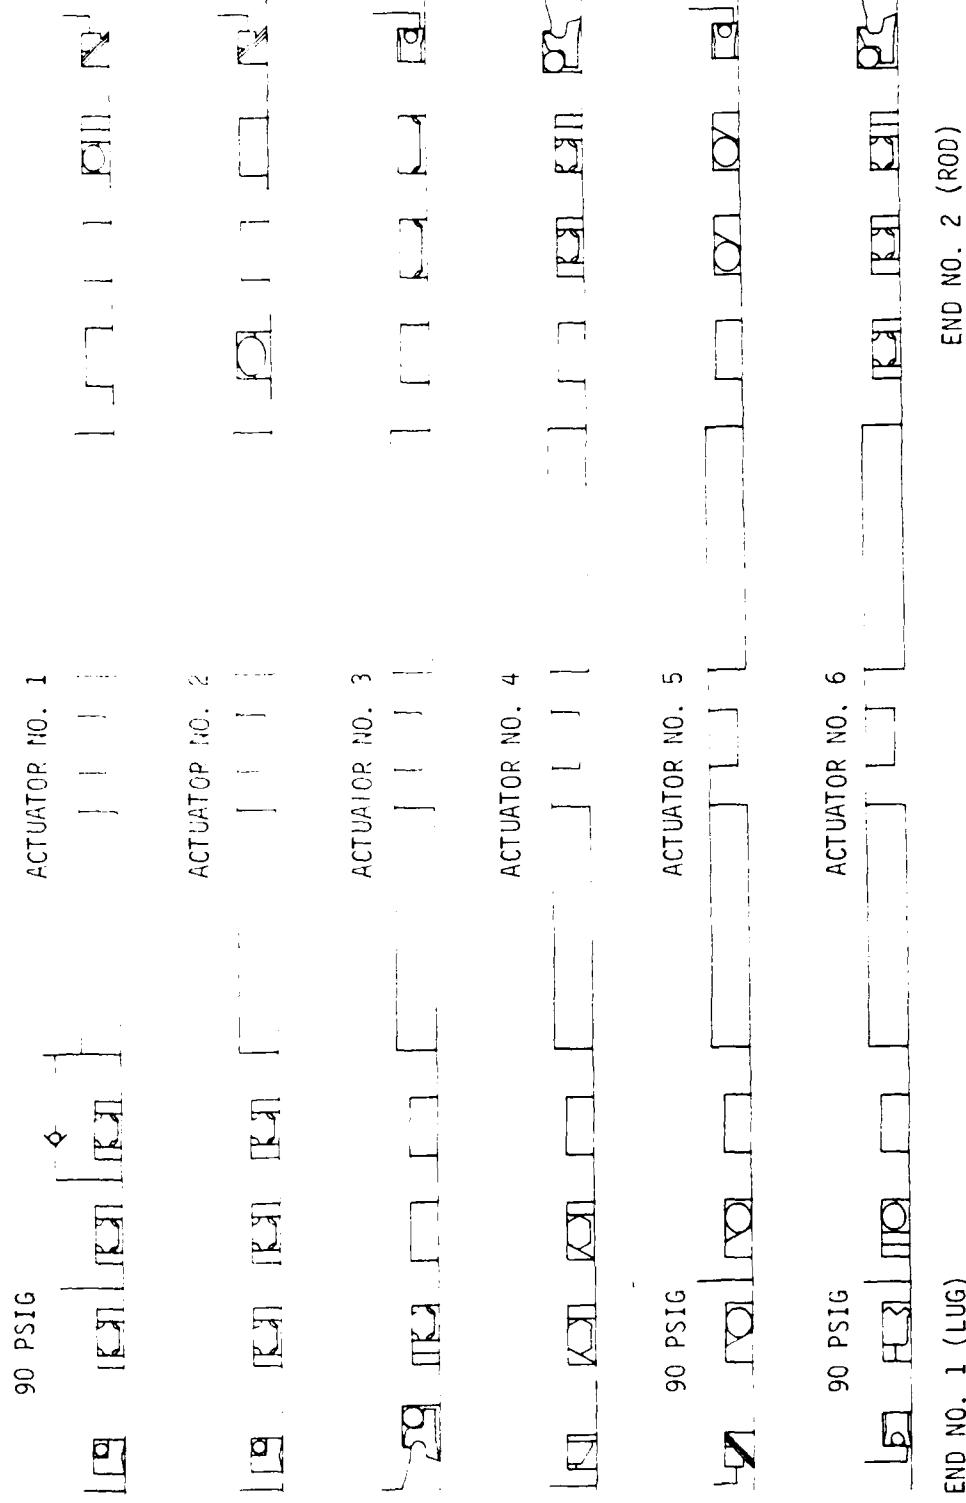
FIGURE 7. SEALS SELECTED FOR TASK III TEST

Both Greene Tweed and Tetrafluor submitted elastomeric loaded seals that were included in the Task III test. All of the seals used in the Task III test are shown in Figure 7 and described in Table 7.

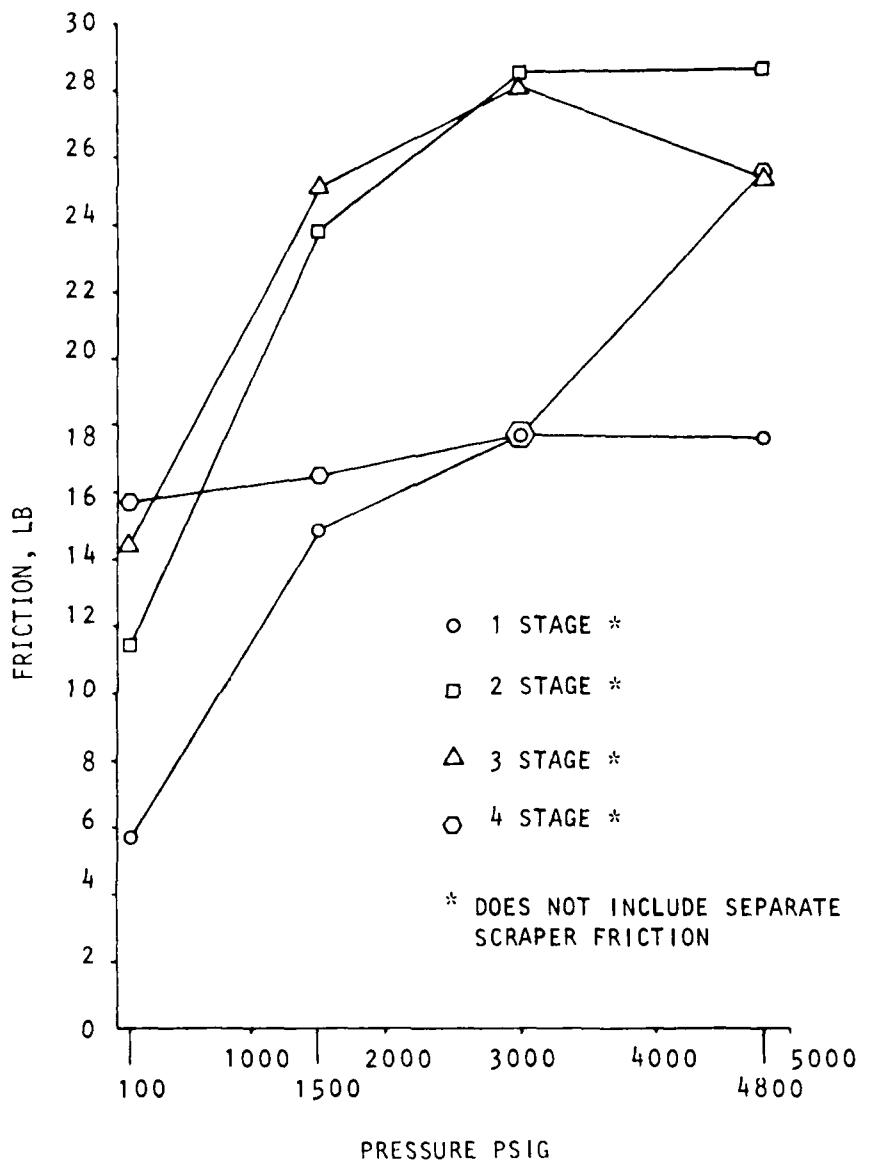
FIGURE 8. PRESSURIZED FRICTION OF TASK III SEALS

The average pressurized friction for the Task III seals is shown in Figure 8. The unpressurized friction for the seals is shown in Table 11. The daily leakage for the seals is shown in Tables 9 and 10. A performance summary for each seal is given in Table C-1 in Appendix C. The measured critical dimensions for each actuator are given in Table C-2 in Appendix C.

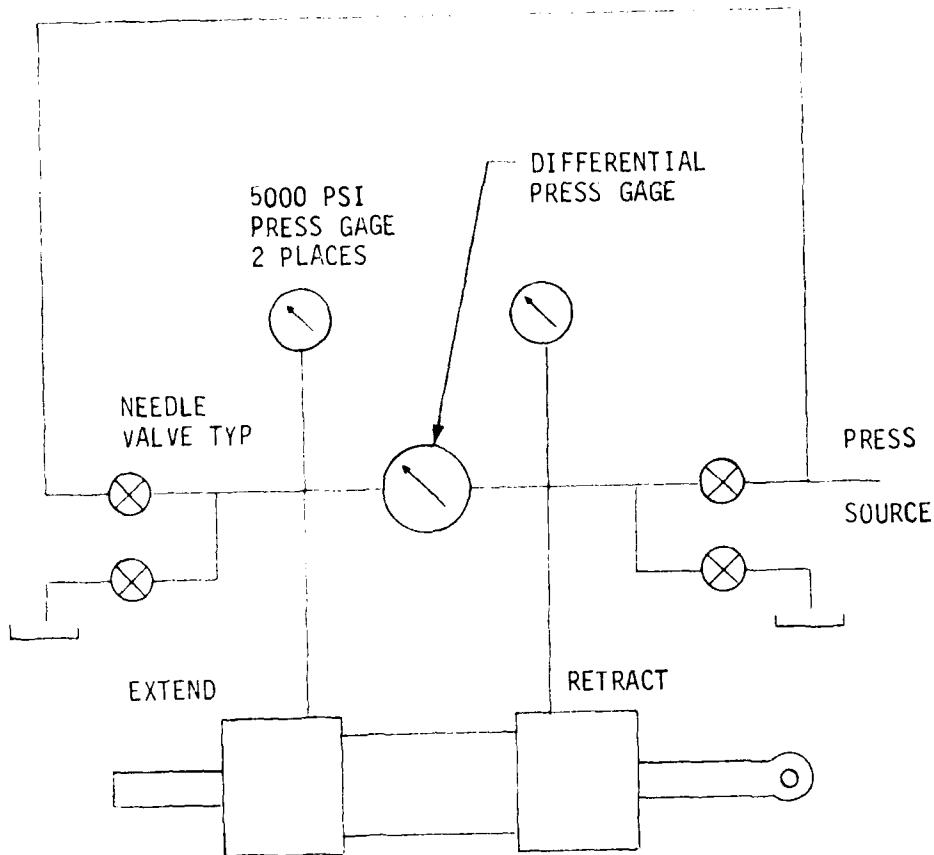
FIGURE 3.2.5

PRESSURIZED FRICTION SET-UP
